Manhole Inspection Summary

Manhole # S07MM1046MH

Insp Date: **1/20/09 3:14 PM**

Location Address: **3717 GARRISON AVE**

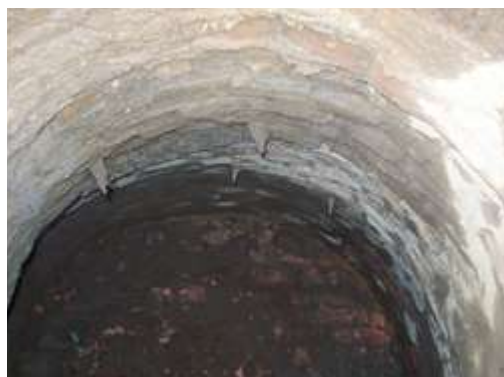
Defect 2

Count: **3** Missing: **3** ☒ **Corroded**

CORRODED STEPS

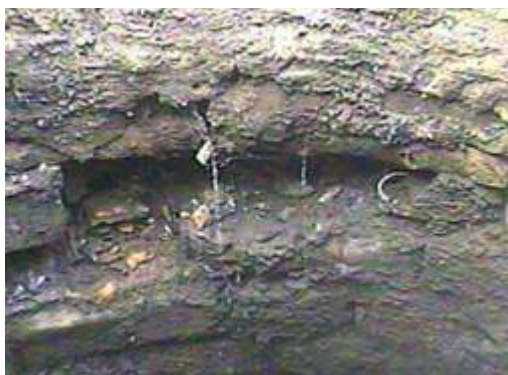
Defect 1

Condition: ☐ Sound ☒ **Cracked** ☐ Root Intrusion ☒ **Loose Brick** ☐ Deteriorated

BROKEN BRICK AND CRACKS ON
CHIMNEY

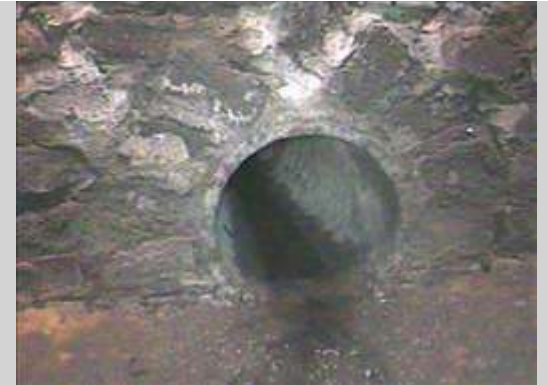
12 O'Clock Outflow

8 in. Circular Gravity Sewer
Pipe Out @ 12 O'Clock

Infiltration: **None** Pipe Seal Cond: **Sound**
